Descent Below Visual Glidepath and Impact With Seawall
Asiana Airlines Flight 214
Boeing 777-200ER, HL7742
San Francisco, California
July 6, 2013

NTSB/AAR-14/01
PB2014-105984

Aircraft Accident Report

Descent Below Visual Glidepath and Impact With Seawall

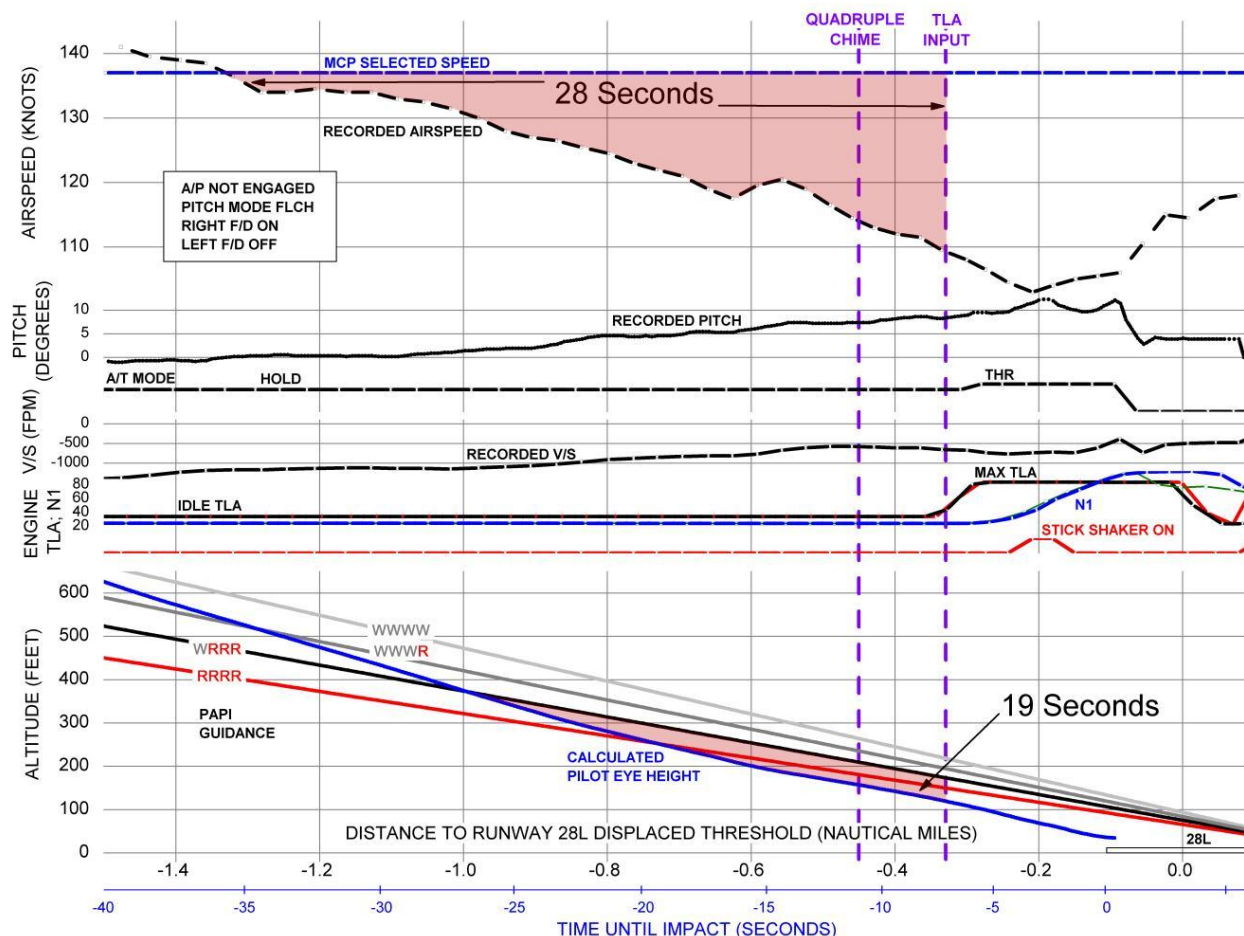
Figure 4. Profile view of the last 40 seconds of flight 214.

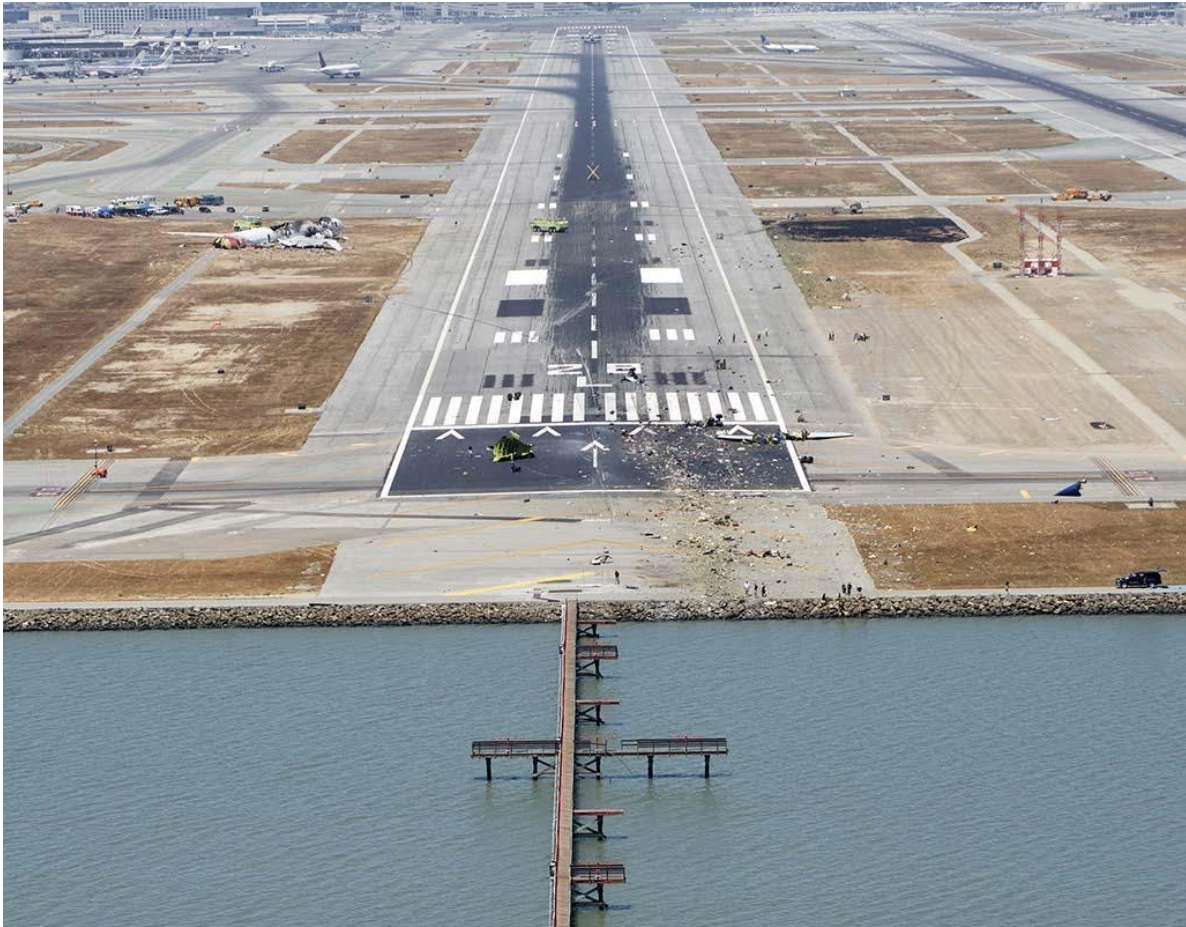
Figure 5. Aerial view of the flight 214 wreckage.

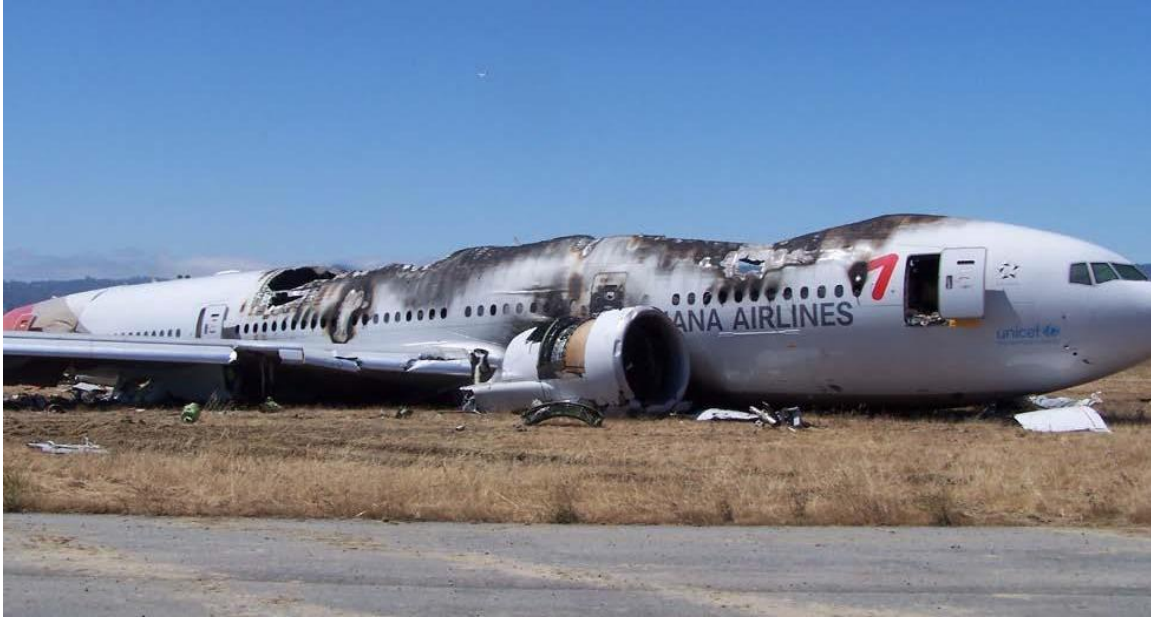
A fire erupted during the accident sequence and destroyed sections of the airplane before being suppressed by firefighting personnel. Portions of the fuselage crown structure above the window belt were burned through from about body station⁶¹ (BS) 358 aft to about BS 1434. The cabin interior above the passenger floor from about the cockpit door aft to about BS 1434 was partially consumed by fire. Figure 11 shows fire damage to the airplane.

Figure 11. Fire damage to the fuselage of flight 214.

Examination of the accident site and the airplane's fuel tanks showed no evidence of postcrash fire involving fuel. As previously noted, the right engine's oil tank was breached and partially melted; thermal damage signatures around the oil tank were consistent with an oil-fed fire. The fuselage in the area where the right engine came to rest (BS 825 to 867) showed severe heat damage but no penetrations other than rivet holes and minor cracks. The door 2R external skins were burned away, but the fire did not penetrate internal insulation and mechanisms into the cabin. However, below the cabin floor in the cargo bay, severely burned ducts, thermal acoustic insulation, and composite floor beams were found between BS 755.5 and 888 behind the cargo compartment liner. The path of the fire was traced from this area, up the environmental control system riser duct bay between BS 825 and 846 and into the overhead area.

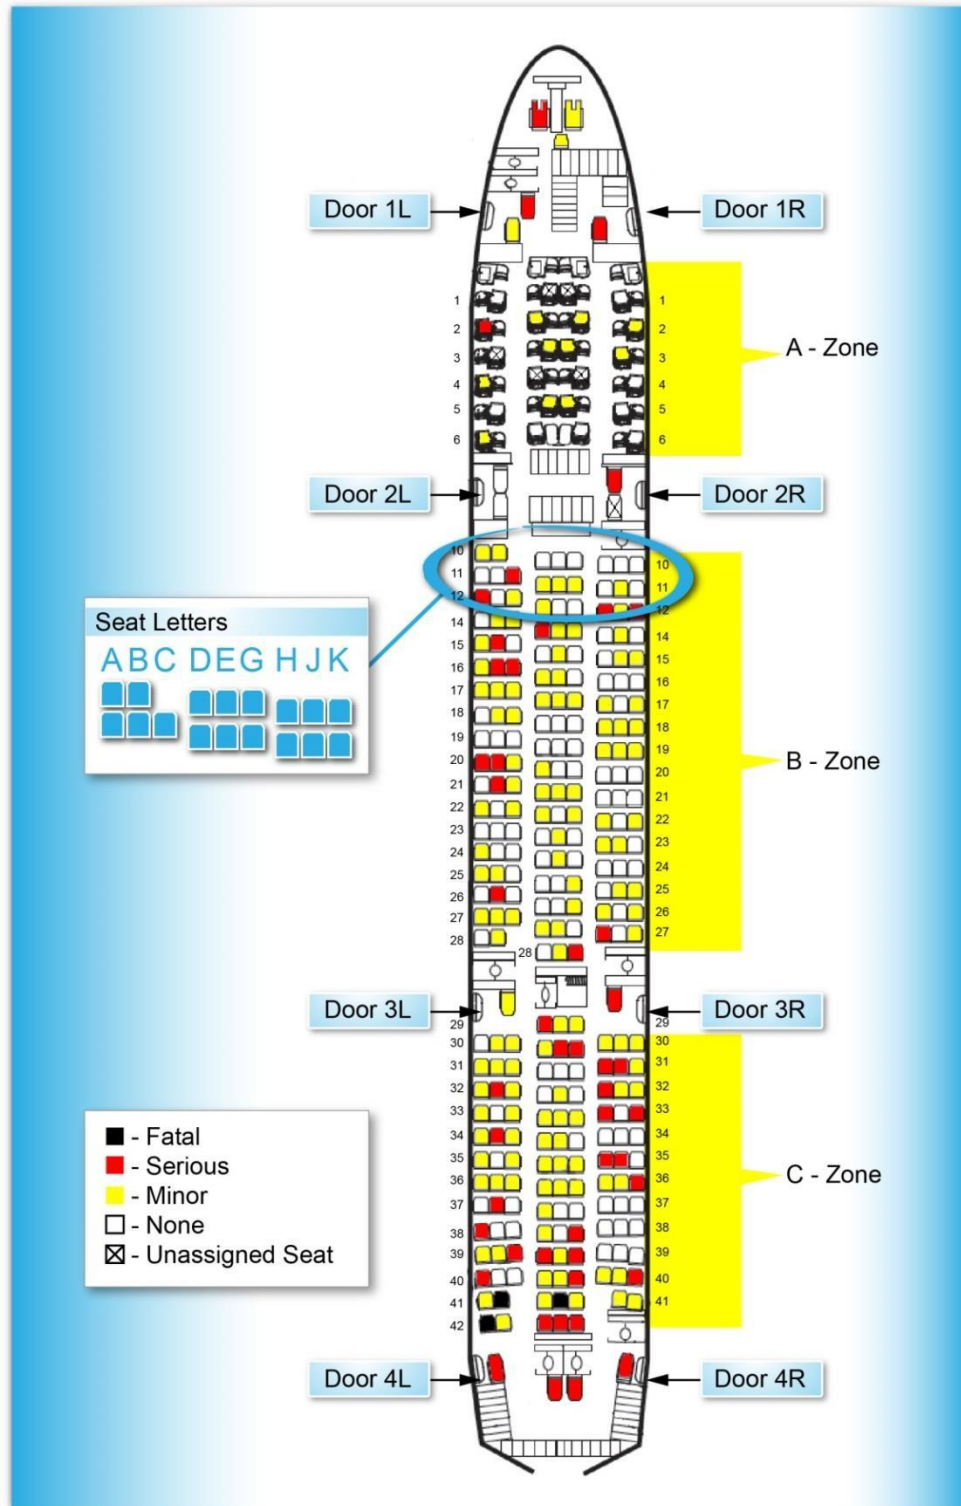
Figure 12. Diagram of flight 214's cabin configuration including injury classification based on assigned seat.

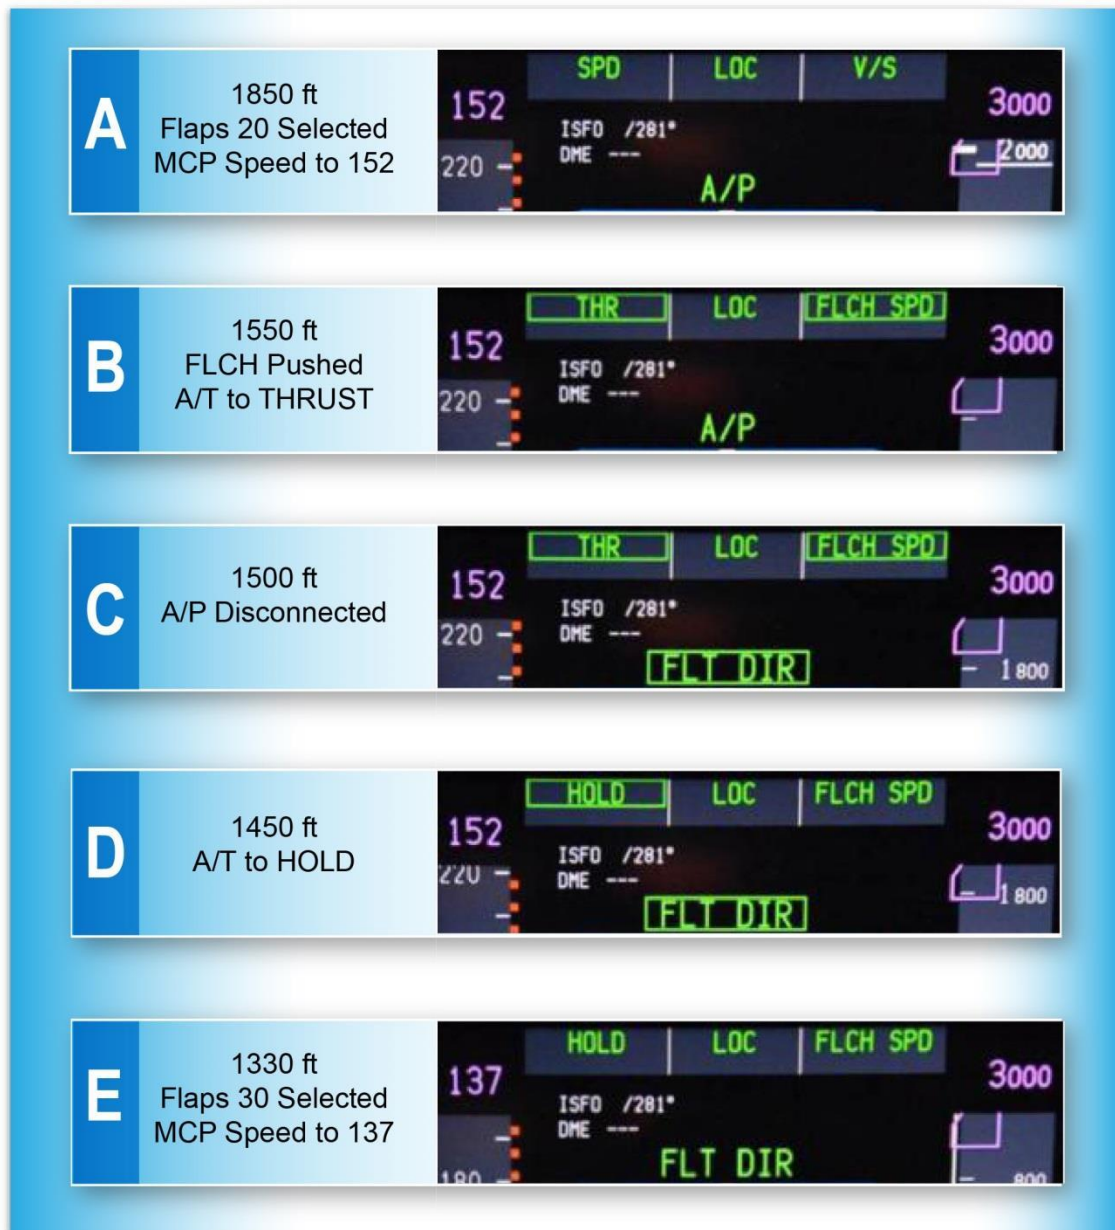
The flight crew's difficulty in managing the airplane's vertical path continued as the approach progressed. The PF was aware of the need to lose excess altitude and attempted to do so using FLCH SPD pitch mode, which initiated a sequence of events that had the unintended consequence of deactivating automatic airspeed control. The changes on the FMA that occurred during the airplane's descent from 1,850 to 1,330 ft msl, when it was between about 4.5 and 3.0 nm from the runway threshold, are shown in figure 14 and discussed below.

Figure 14. Automation sequence from 1,850 to 1,330 ft msl.

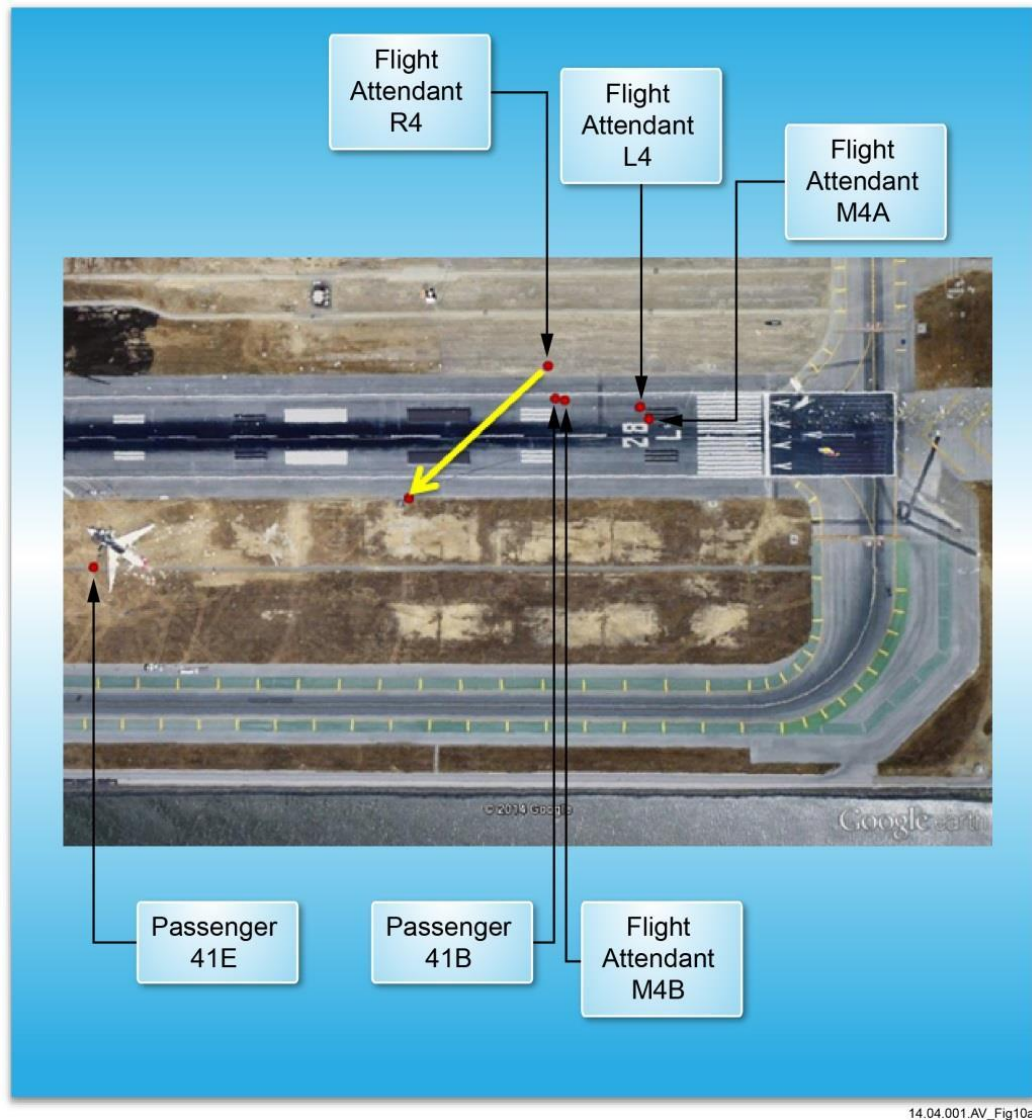
¹⁰⁴ In postaccident interviews, students seated in the same row as passenger 41E reported that she was not wearing her seatbelt for landing. Flight attendants and passengers reported that at least two flight attendants performed prelanding seatbelt compliance checks in C-zone and were "very diligent" in ensuring compliance with seatbelt regulations.

Figure 15. Location where ejected occupants were found.

Passenger 41E was found in front of the left wing. Three possible scenarios could explain how passenger 41E arrived in front of the left wing after the impact sequence: (1) she arrived at the location under her own power; (2) she was taken to the location by an emergency responder or other passenger after being rescued from the airplane and forgotten; or (3) she was ejected from the airplane and landed at that location.
